OIL MAINTENANCE
INDUSTRY

Industrial Gear Box, Conveyor Belts, Coal Terminal

CJC™ Application Study

BMA. Coal Loading Terminal, Hay Point, Queensland Australia.

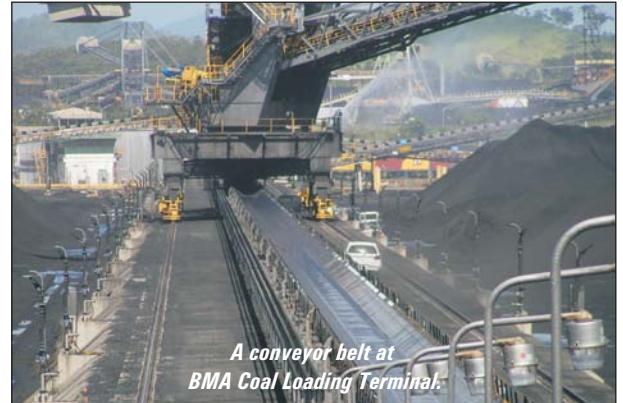
A conveyor belt at BMA Coal Loading Terminal.

David Brown gearbox, 180 L of BP GRXP 320 (ISO VG 320). The gear box is driving a conveyor belt, which transports coal.

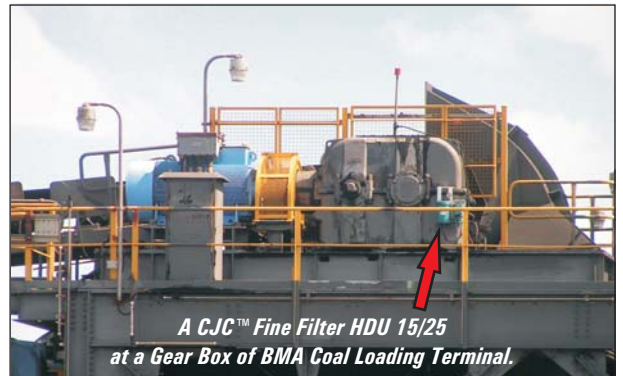
A CJC™ Fine Filter HDU 15/25 at a Gear Box of BMA Coal Loading Terminal.

A CJC™ Fine Filter HDU 15/25 PV was installed with a flow rate of 45 litres per hour and using a CJC™ Filter Insert BG 15/25 with a dirt holding capacity of 1.5 litres.

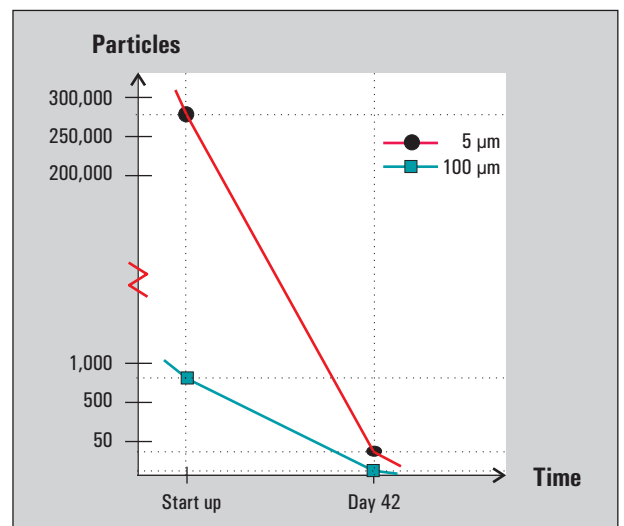
PARTICLE REDUCTION

Particles	5 µm	100 µm	ISO code
Before	> 275,402	> 865	> 22/22/17
After	34	5	15/13/12

Upon start up a result of greater than ISO 22/22/17. The contamination in the oil was greatly reduced over a 42 day period. The ISO particle count on day 42 is 15/13/12.
