CJC™ Application Study

Ship: **M/V "Island Scout"**
M/V "Island Pride"
Ship owner: Island Offshore Management AS
Contact person: Trond Hauge

CJC™ Desorber D10 with built-in heat exchanger and pump.

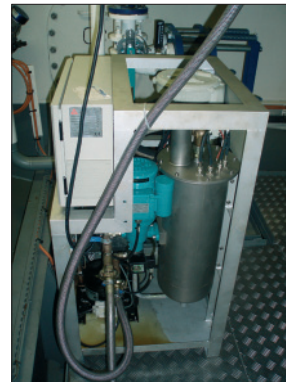
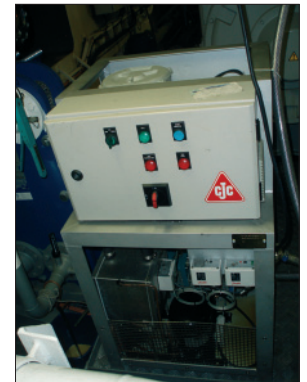
The CJC™ Desorber circulates approx. 45 L/h and needs only 10A as the heater is only of 0.6 KW, 1 phase.

The desorber was put into operation in the afternoon on 2007.05.08. 15 hours later the desorber had removed approx. 5 L of water. Over the following 24 hours the desorber removed additional 5 L of water and the last oil samples showed a water content of less than 0.05%.

The CJC™ Desorber D10 was in operation for approx. 60 hours before an oil sample was taken. Over the same period, approx. 26 L of water was removed from the stern tube oil. Before the desorber was started, an oil sample showed 8% of water, corresponding to approx. $(450 \times 8/100) = 36$ L of water in the stern tube.
