CJC™ Application Study

Energyworks Cartagena - Iberdrola, Spain.
Cogeneration combined cycle power plant inside
SABIC refinery.

Cogeneration combined cycle power plant of 95 MW.
2 x GE gas turbines of 42 MW.

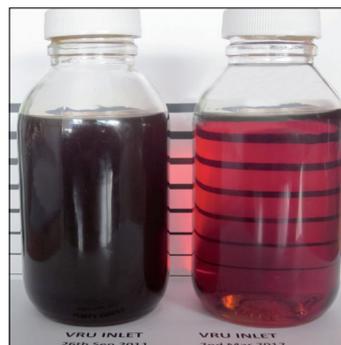
Samples taken, before and after filtration with the CJC™ VRU

The MPC dropped from 55 to 15 within 30 days. No varnish contaminants on the inline filters after the filtration with the CJC™ VRU.

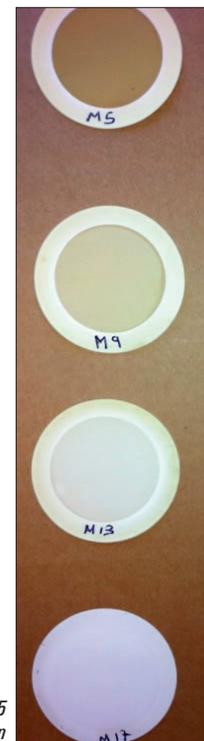
Varnish coated in-line filter of IGV servo valve hydraulics, before and after filtration with CJC™ VRU

MPC dropped from 55 to 15 after 30 days of filtration
