Gear Oil Coal-Fired Power Plant, Mill Drive Gearbox CJC™ Application Study

Application Study

Millmerran Power Station.
Division of Intergergen, Queensland, Australia.
850 MW Low Emission Coal-Fired Power Station.

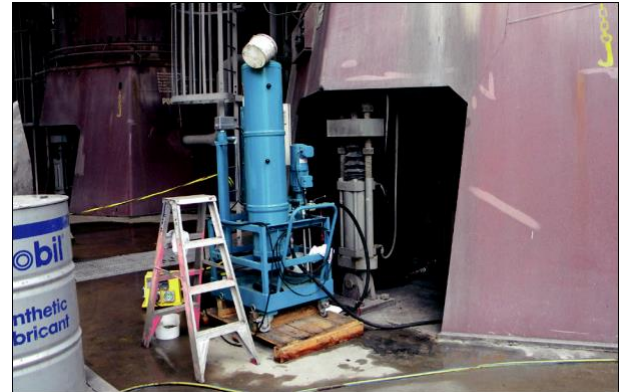
Millmerran Power Station, coal-fired power plant, Australia, with the CJC™ Filter Separator PTU3 27/108 P installed

In utilising an available CJC™ PTU3 27/108 Hire Unit we were able to run the unit on one of the suspect gearboxes, whilst technical staff at the power station took oil samples at intervals.

Jan. 25, 2009 the PTU3 27/108 was installed.
Jan. 27, 2009 oil sample results showed 131 ppm of water and ISO 23/22/19.
Febr. 2, 2009 the results were improved to 36 ppm of water and ISO 18/16/12.
The hire unit was removed and the B Filter Inserts were dried. The contamination weight in each filter inserts equated to 9 kg (metal contamination).
Samples were taken 36 days after, but since contamination was up again (108 ppm of water and ISO 22/22/20), 2 x HDU 27/54 P-E2H1PT were purchased.
This has made it possible to continue operations whilst waiting on parts.

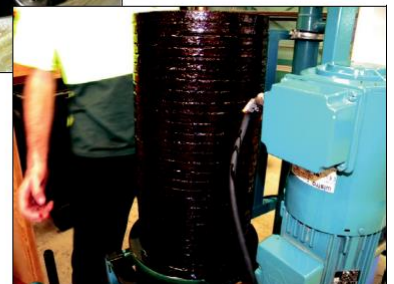
CJC™ Fine Filter HDU 27/54 P

CJC™ Filter Separator HDU 27/54 P-E2H1PT with a flow rate of 250 L/h.
CJC™ Filter Insert B 27/27, with a minimum of 4 kg of dirt holding capacity.
A hire unit, CJC™ Filter Separator PTU3 27/108, was utilised initially to obtain a result.
