CJC™ Application Study

Tap Changer Oil

Transformer Tap Changer

Sishen Iron Ore Mine, Kumba Iron Ore, Northern Cape, South Africa.

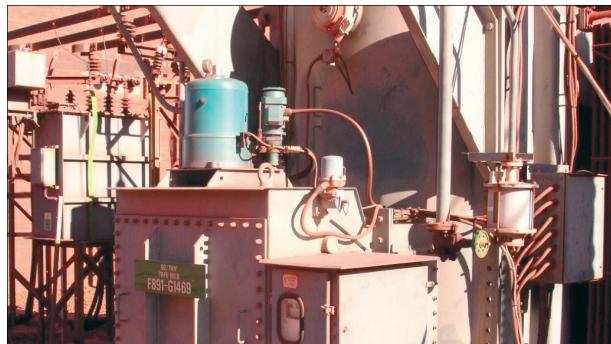
The Transformer Tap Changer at Sishen Iron Ore Company with the CJC™ Fine Filter HDU 27/27 PV installed

CJC™ Fine Filter HDU 27/27 PV (ABB specification) with CJC™ Filter Insert BNK 27/27, flow rate 120 L/h, designed to remove particles, water and oxidation products.
