OIL MAINTENANCE
INDUSTRY

Turbine Oil Hydro Power, Oil Storage Tank

CJC™ Application Study

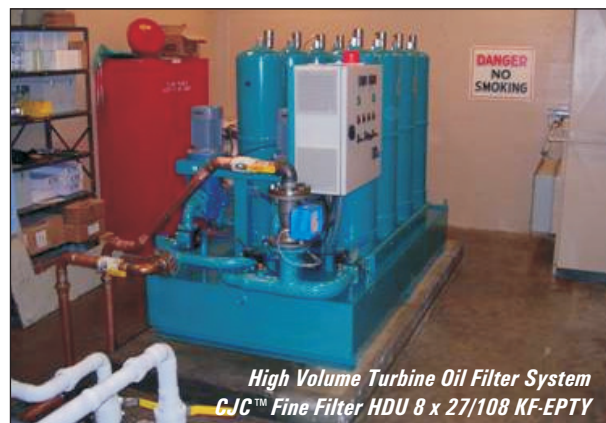
High Volume Turbine Oil Filter System
CJC™ Fine Filter HDU 8 x 27/108 KF-EPTY

A CJC™ Fine Filter HDU 8 x 27/108 KF-EPTY using CJC™ Filter Inserts BLA 27/27 was selected for its high volume capability, fine filtration rating of 3-micron absolute, and the ability to remove varnish by adsorption. The filter system was also the lowest cost system proposed from several vendors.

The system features two pumps for a combined flow rate of 70 gpm (approx. 265 L/min). A variable frequency drive allows for lower flow during periods where a high volume is not needed or when low oil temperatures result in high viscosity.

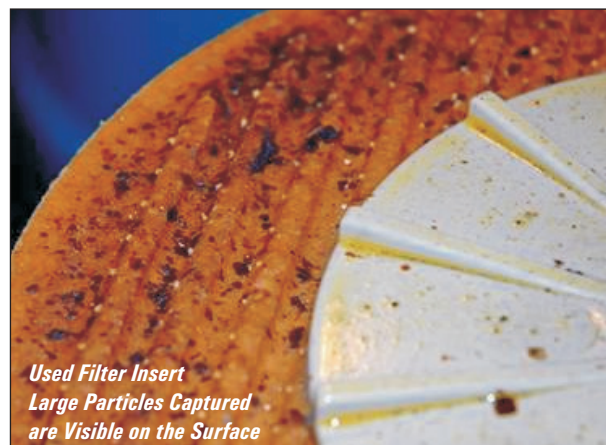
Used Filter Insert
Large Particles Captured
are Visible on the Surface

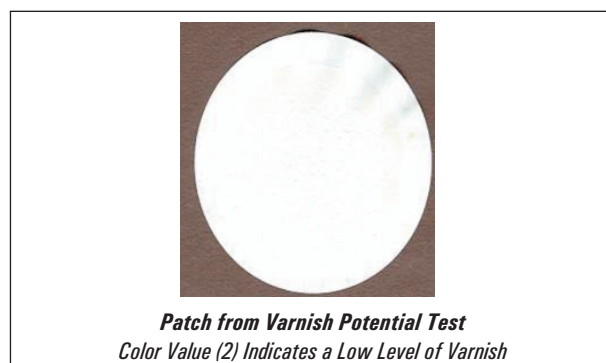
Patch from Varnish Potential Test
Color Value (2) Indicates a Low Level of Varnish

TEST SAMPLE	BEFORE	AFTER
ISO Code	22/19/14	13/10/6
Varnish Potential Color Value	-	2
