**CLEAN OIL
BRIGHT IDEAS**

Gear Oil Symons Crushers, Iron Ore

CJC™ Application Study

Kumba Iron Ore's Sishen Mine, South Africa

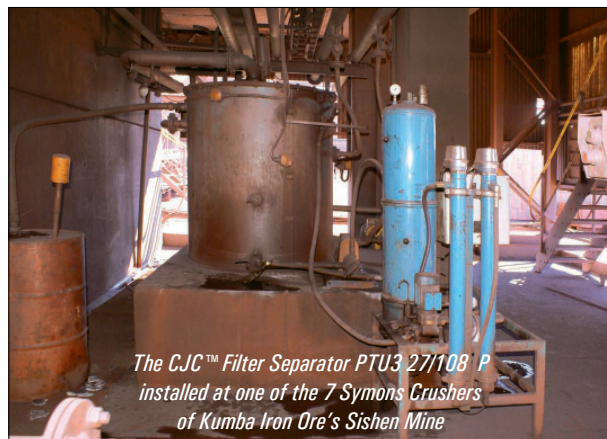
The CJC™ Filter Separator PTU3 27/108 P installed at one of the 7 Symons Crushers of Kumba Iron Ore's Sishen Mine

CJC™ Filter Separator PTU3 27/108 P-E2H1PW with a flow rate of 400 litres/h, 2 x 4.4 kW preheaters and **4 x CJC™ Filter Inserts BLAT 27/27**, capable of retaining up to 16 litres of contaminants.
